Lake Los Carneros Trail Management, Rehabilitation And Interpretive Program Review

Santa Barbara County Trails Council • September 2009

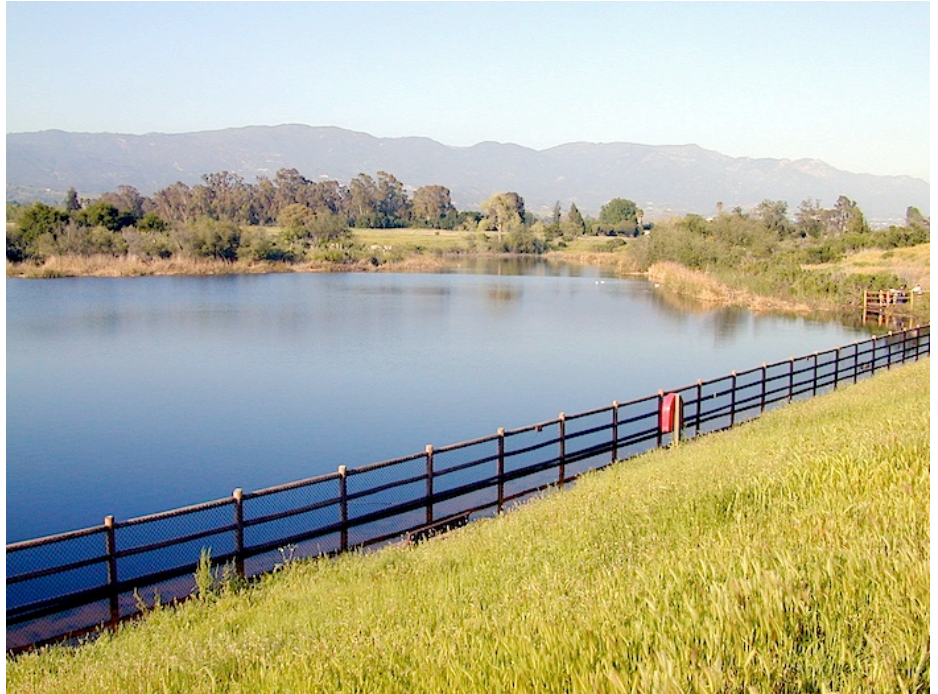
However, towards the west end of the lake, the asphalt is severely degraded in places and is in somewhat poor condition for several hundred yards along the west side of the lake nearest Stow House.

While there really isn't a standard for maintaining paved walkways, at some point the City will need to address maintenance, either by repairing the asphalt, removing it replacing it with something like decomposed granite or providing a combination of asphalt and decomposed granite so users have a choice of surfaces on which to walk.

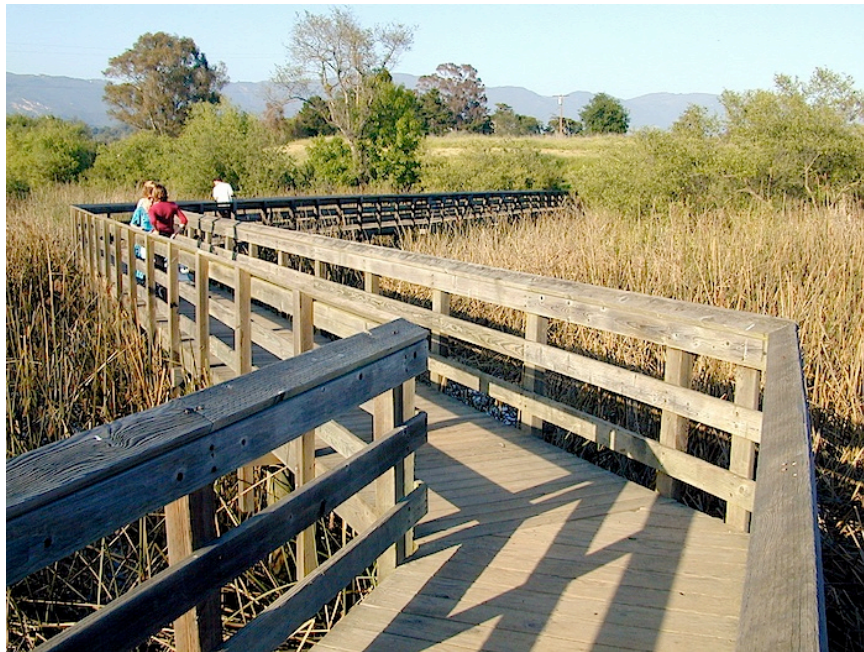
Despite the opportunities the bridge offers for viewing wildlife, the bridge is not accessible for the handicapped from either end. At a minimum SBTC recommends re-routing the trail on the west end of the bridge so handicapped access is available from the asphalt walkway on that side.

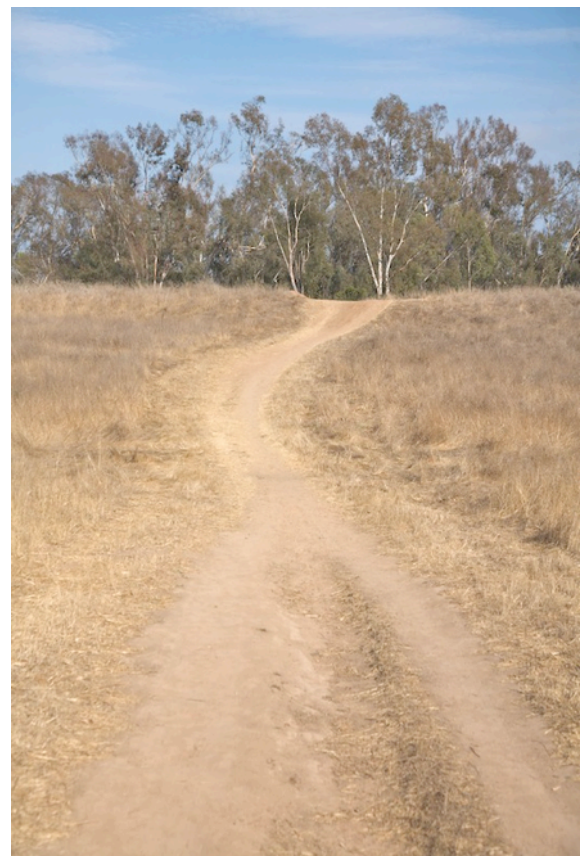
Trail on the right is typical of many of the Primary Trails though in need of maintenance due to gullyng. Grass has been cut back 5- 6' on either side, encouraging users to wander off of the existing tread. Some erosion control is needed to minimize gullyng.

Despite its reasonably good condition, uneven trail tread, gullying and excessive tread width are present on portions of many of the Primary Trails. In particular, excessive width is difficult to deal with given that once the trail is wider and the ground compacted, it isn't easy to get people to stay off the wider edges or for anything to grow there. SBTC recommends planting native vegetation and California oaks along these sections to enhance the trailside habitat and guide people to the main part of the tread.

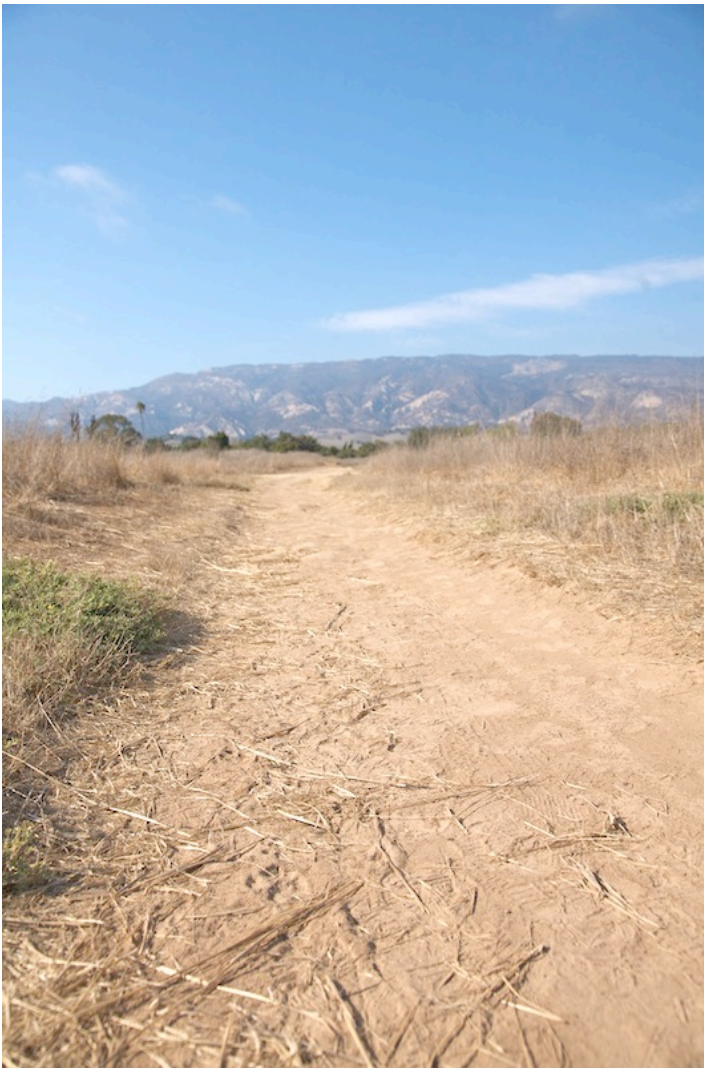
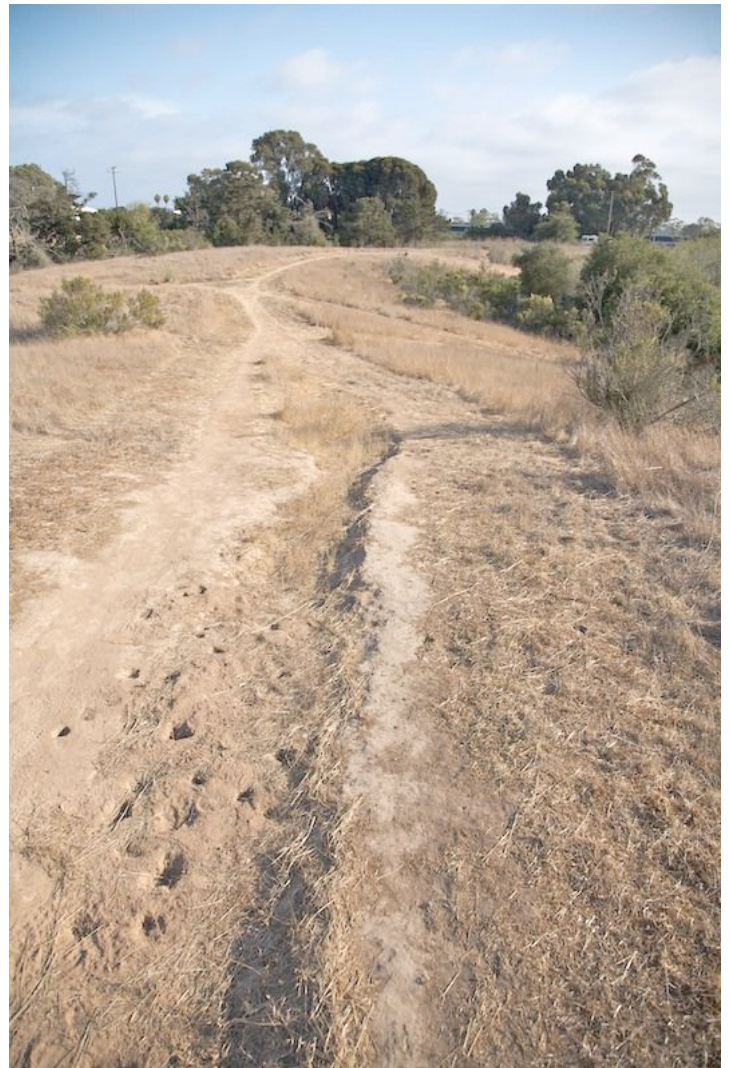
Trail on left has tread that is about 6' wide and approximately 12" below surrounding meadow areas, making it impossible for water to travel anywhere but down the trail. Trail segment on the right is severely gullied, forcing users to the right or left of the channel and widening the trail. Note that the trail narrows again in the distance where the gullying no longer occurs.

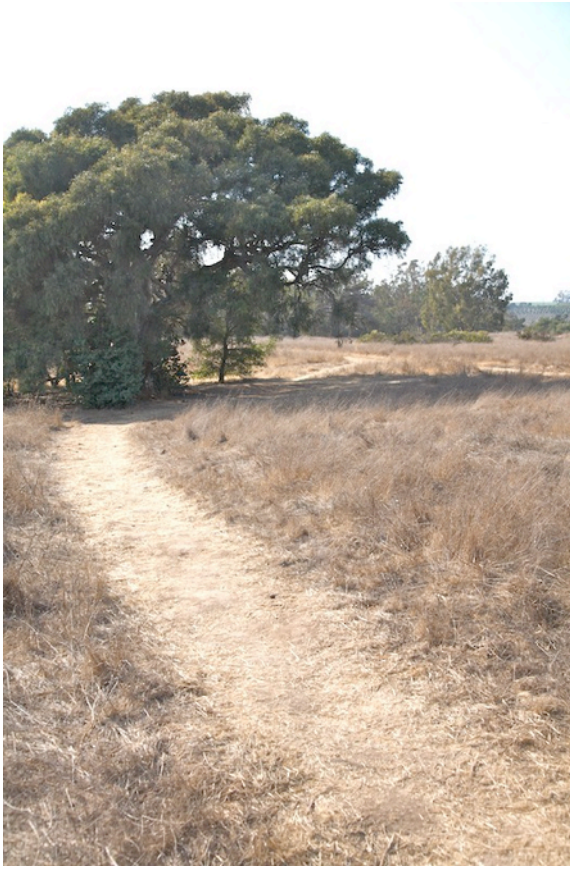
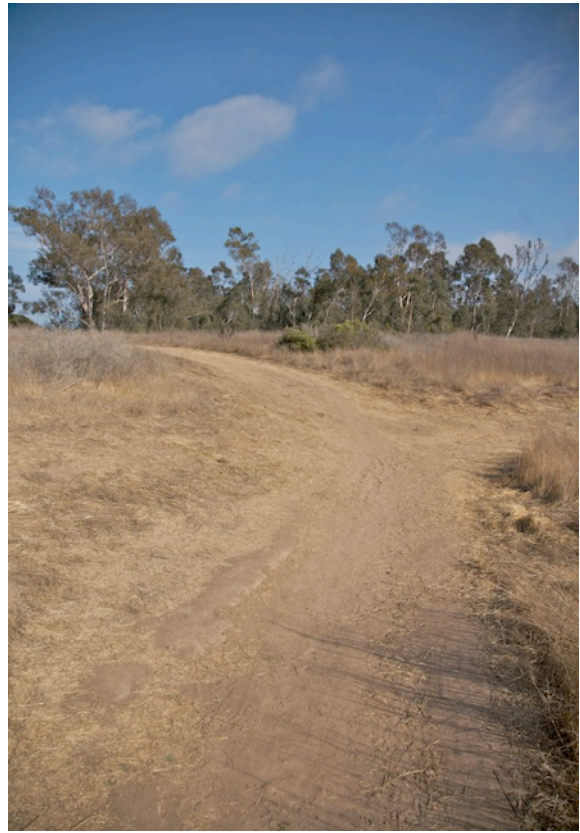
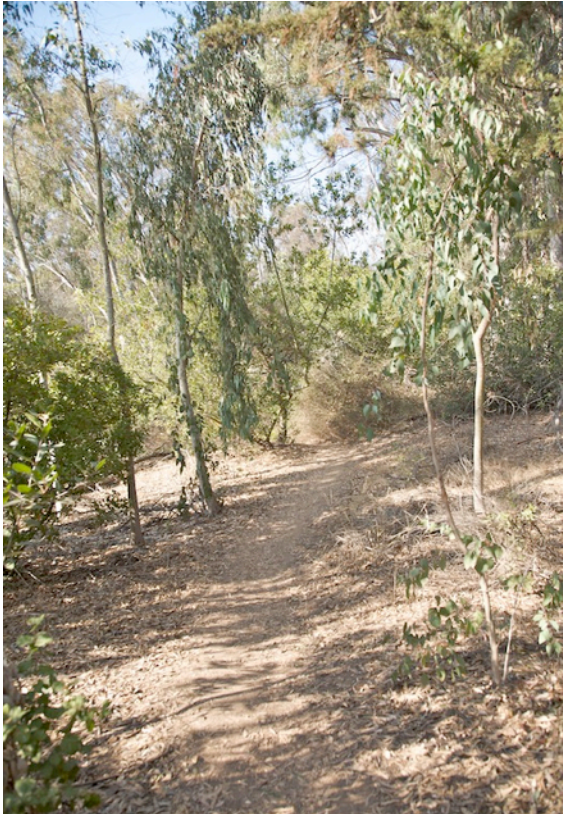
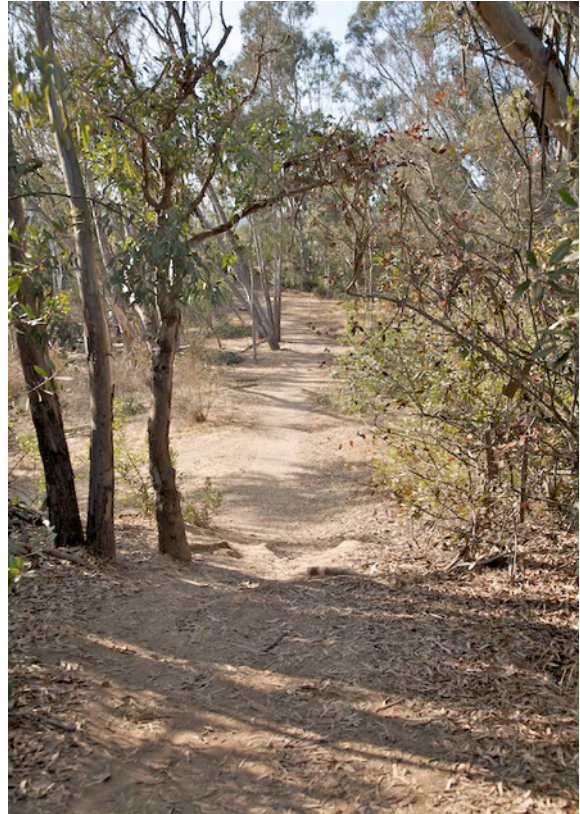
Trail segments that all need improvements including widening the tread in the upper left; narrowing the tread width in the upper right; and brushing to improve sight lines in the lower left and lower right. Note the lower right trail section drops too steeply down into the eucalyptus “bowl.” Re-routing to the right to lessen the grade would be helpful.

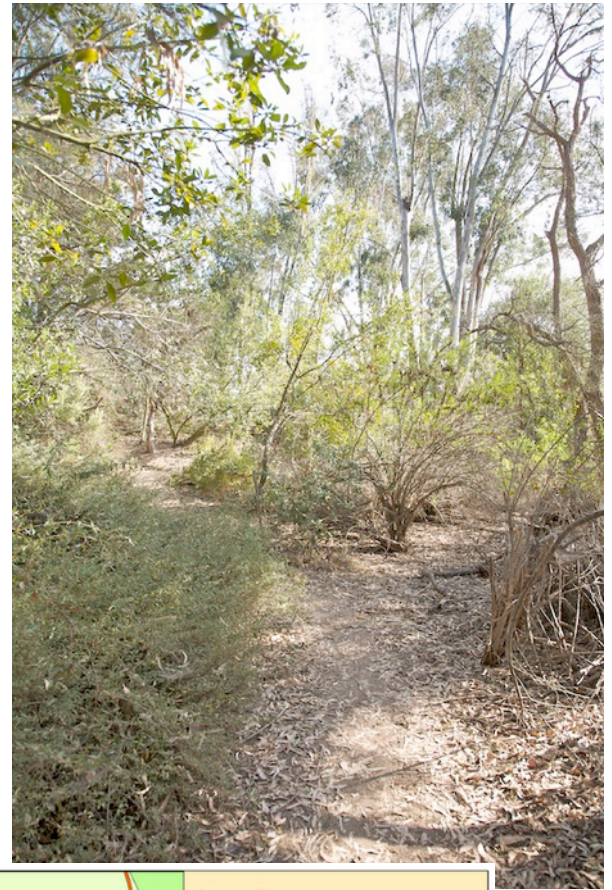
Trail on right is typical of many of the more primitive trails that SBTC has classified as “non-conforming.” Though it is suitable for the public, it needs both brush and line-of-sight improvements. However, issues such as habitat or wildlife values, however, may make it unsuitable for other reasons. Map below shows non-conforming trails overlaid on top of habitat.

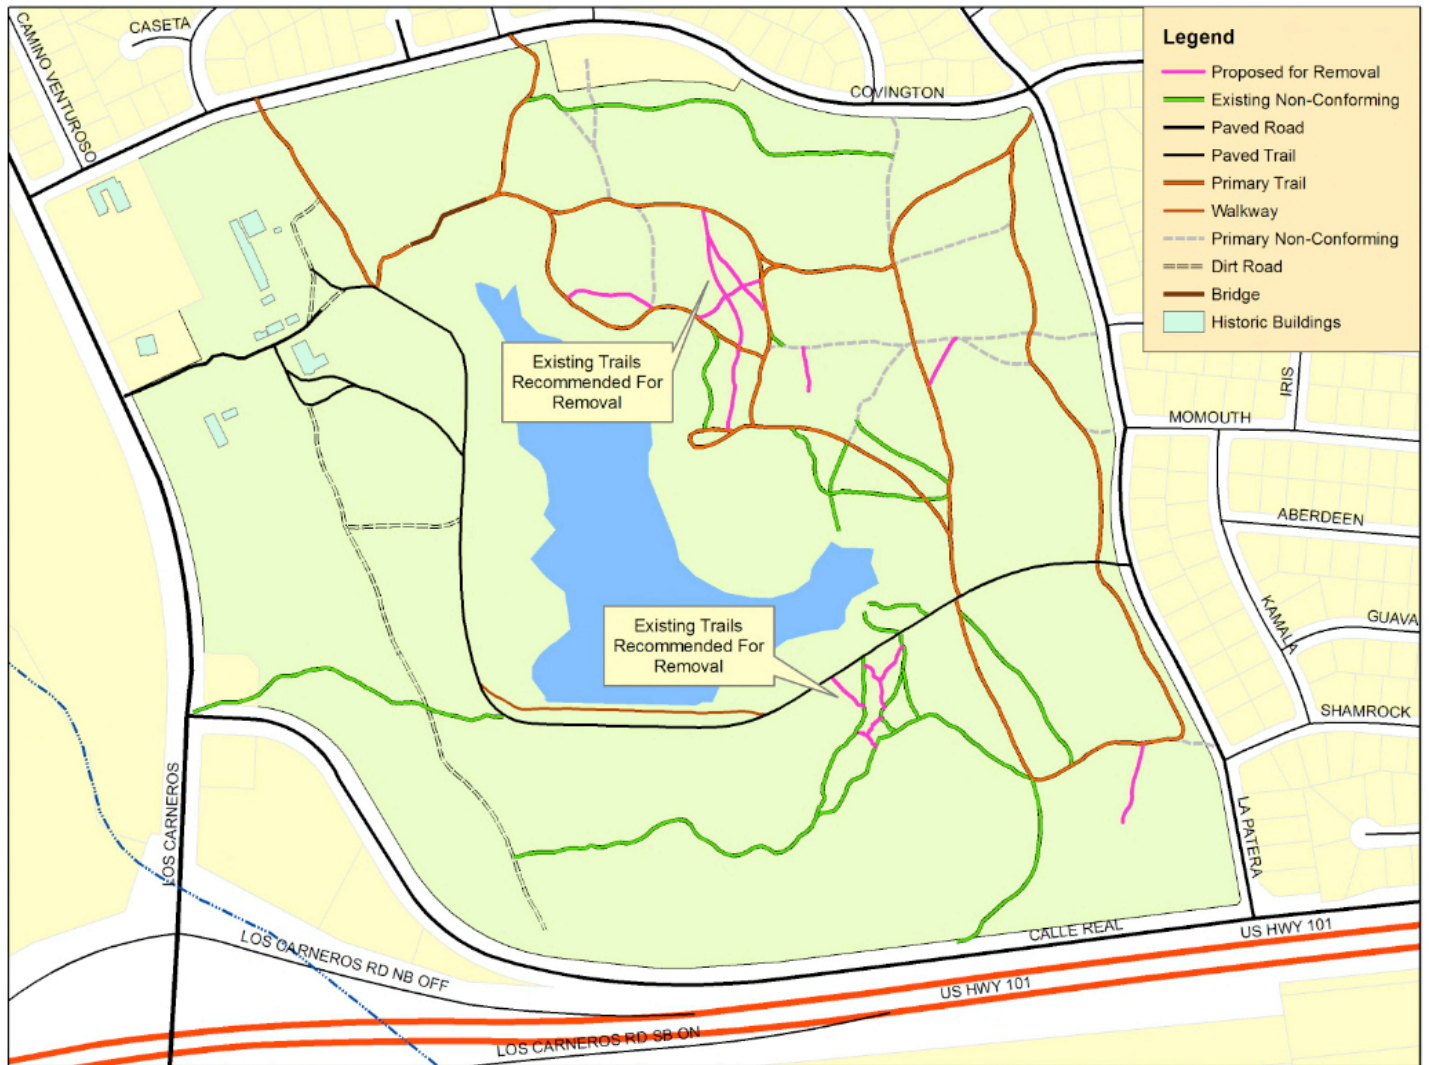
SBTC has identified a number of other non-conforming trails (shown in purple) in Figure 5 that we believe either serve little purpose, impact habitat or other values too much or increase erosion to the point that they need to be removed. For these reasons we recommend they be eliminated.

Figure 5. Many of the trails proposed for removal go nowhere, have serious erosion issues, provide shortcuts of little value or pass through sensitive wildlife habitat.

Removing existing trails provides their own challenges. While complete restoration of a site involves a fairly complex and long-lasting process, SBTC proposes an initial set of steps designed to direct the public away from entry points for the trails being removed and towards existing approved trails. This can be accomplished by:

- Digging up the trail tread to loosen compacted soil along the tread and discourage use.
- Spreading vegetation, branches and other materials along the trail to provide a more natural look and hide the old trail.
- Planting native vegetation at the entry points to these trails, thus cutting off entry to them as well as contributing to the natural setting.
