Lake Los Carneros Trail Management, Rehabilitation And Interpretive Program Review

Santa Barbara County Trails Council • September 2009

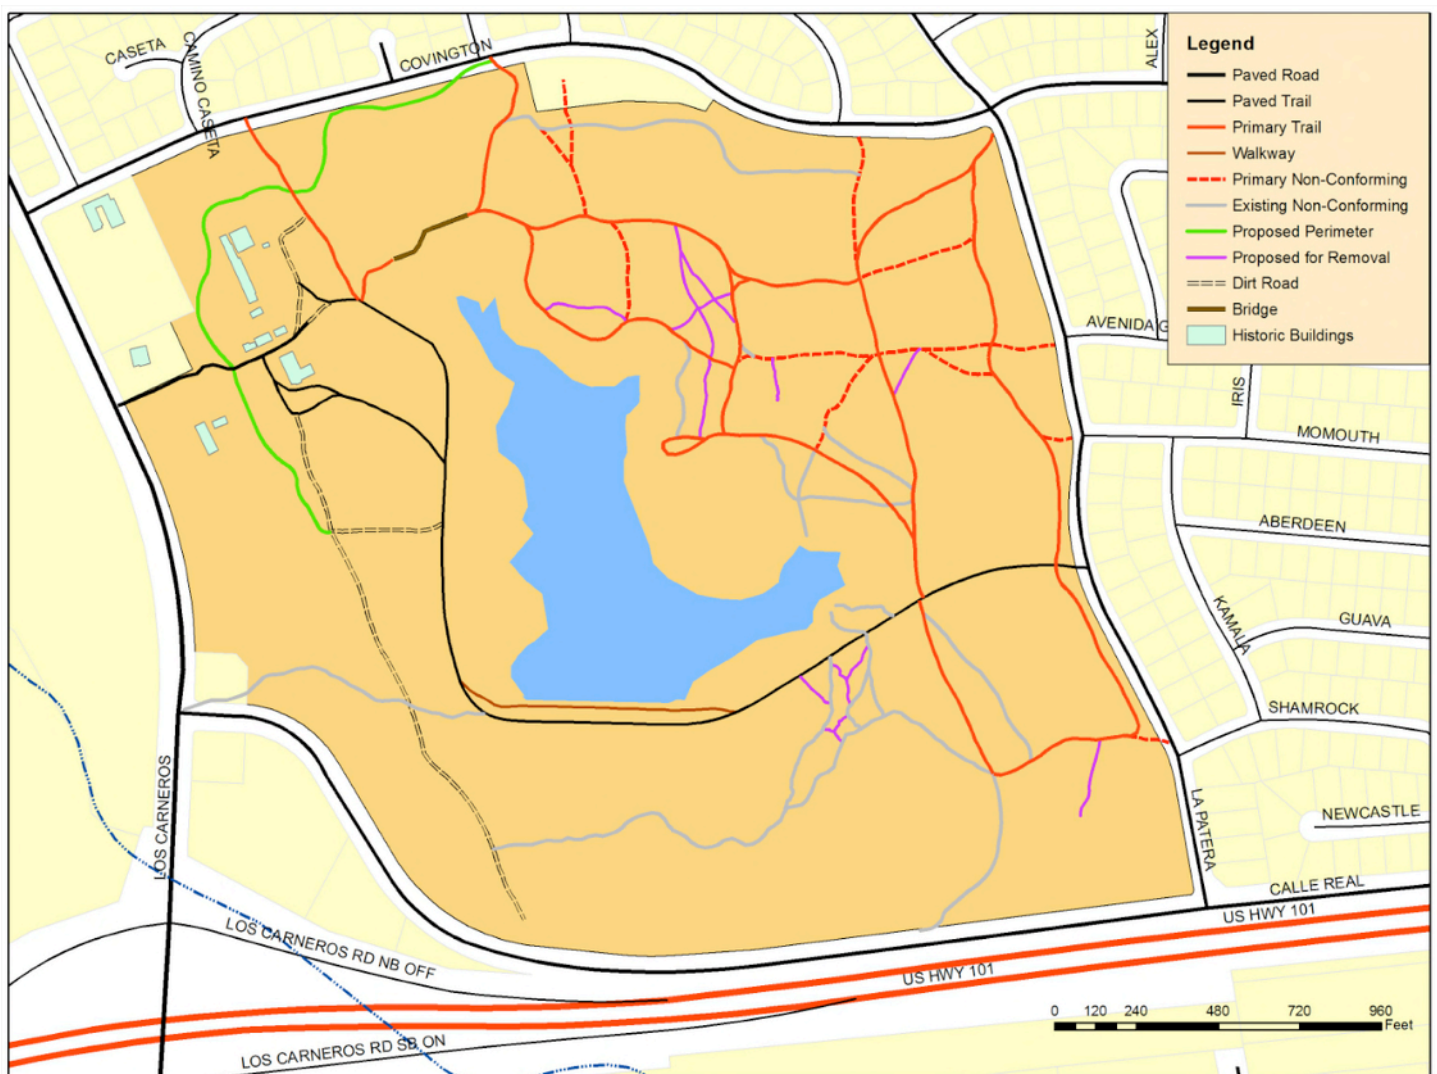
Figure 2. Map shows current trail locations throughout Lake Los Carneros, including the Primary Trails recommended by Penfield & Smith, several types of non-conforming trails, including connections to the primary trails, lesser used routes (shown in gray) as well as a number of other routes recommended for elimination (shown in purple). The result is a poorly designed and maintained network of trails that is in need of update.

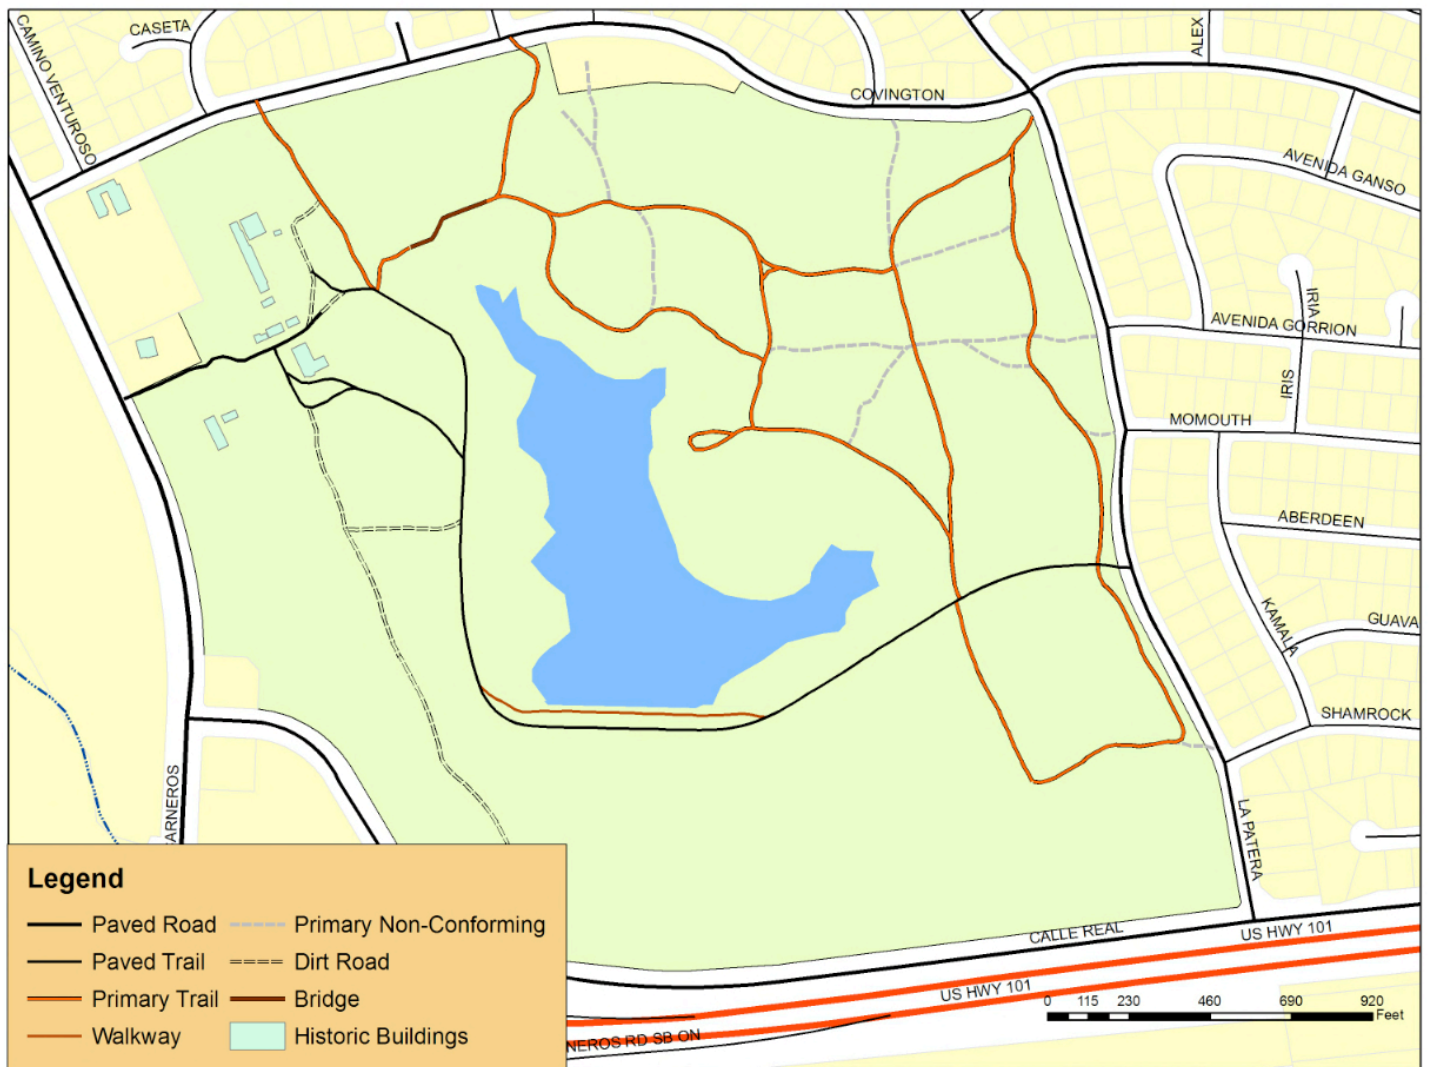
Figure 3. The trails network recommended in 1999 focused on those shown in red along with several old paved roads, walkways and one bridge. Today, these trails are still the main ones used by the public. Note the connecting trails shown in gray. These represent routes that would have been removed if the 1999 recommendations had been implemented.

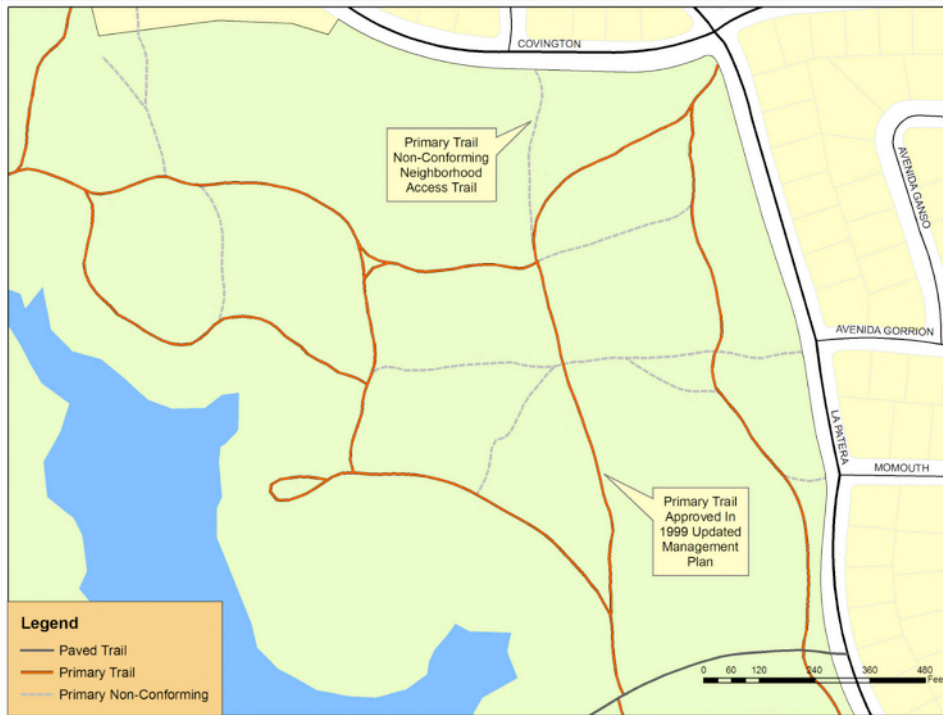
The Primary Trails, shown below in red, comprise the heart of the trail network at Lake Los Carneros. These trails provide access to about half of the park, meandering through open meadows, mostly on level or near-level ground. The trails vary in width from 3-8 feet and are in relatively good condition.

Despite its reasonably good condition, uneven trail tread, gullying and excessive tread width are present on portions of many of the Primary Trails. In particular, excessive width is difficult to deal with given that once the trail is wider and the ground compacted, it isn't easy to get people to stay off the wider edges or for anything to grow there. SBTC recommends planting native vegetation and California oaks along these sections to enhance the trailside habitat and guide people to the main part of the tread.

SBTC recommends that trails designated as Primary Trails be a minimum of 4' wide and no wider than 6'. In a recent survey of the trails, it was noted that where the primary trails were less than four feet wide parallel trails often

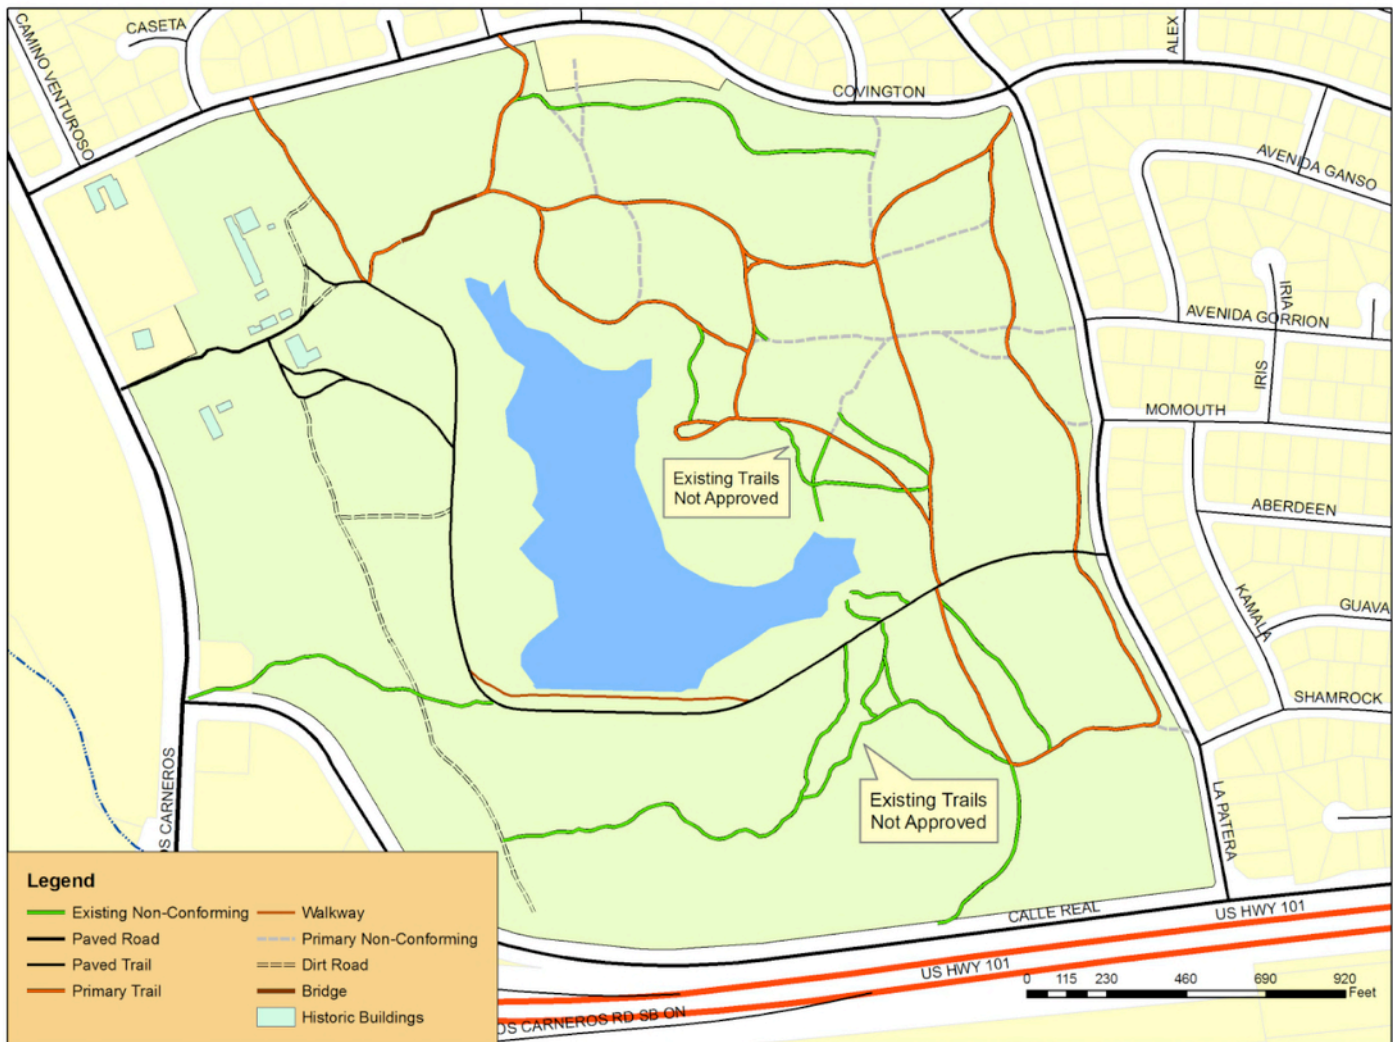
Figure 4. Over the past several decades more than two dozen informal social trails have developed at Lake Los Carneros. SBTC has identified a number of these as suitable for removal for a number of reasons along with the fifteen trail segments shown in green that may have potential for inclusion in the trail network under the classification of “Secondary Trails.”

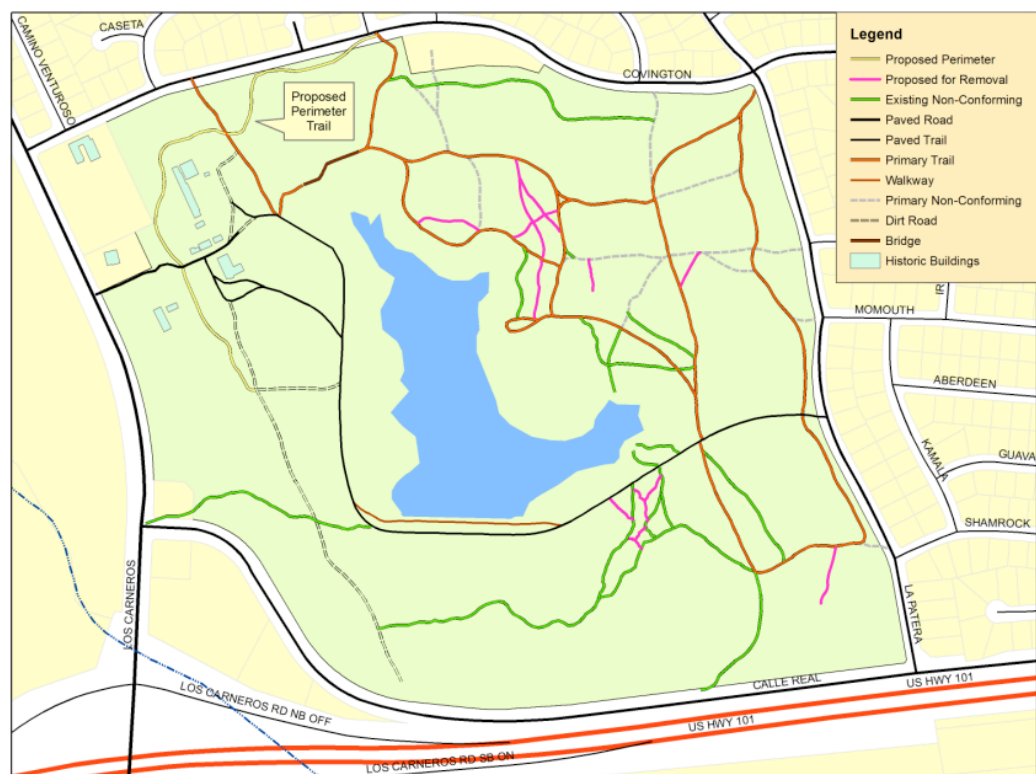
Note proposed perimeter trail shown at right in yellow. The trail would provide the potential for the development of a longer loop route that would follow the outer edges of most of the park, providing joggers, bicyclists and other users with a much longer trail experience.

as a part of reviewing the current trails system, SBTC has identified at least one perimeter trail segment it would recommend for possible inclusion into the Los Carneros trail network. This trail would lead around the northwest side of the park from a point starting at the Stow House parking area and following the outer edge of the park to the Los Carneros Swimming Pool area.
